Significance and Disturbance Study of Devonshire Beach—Lesser Slave Lake Provincial Park

Geowest Environmental Consultants Ltd.
Suite 203, 4208 – 97 Street
Edmonton, AB T6E 5Z9

September, 2004

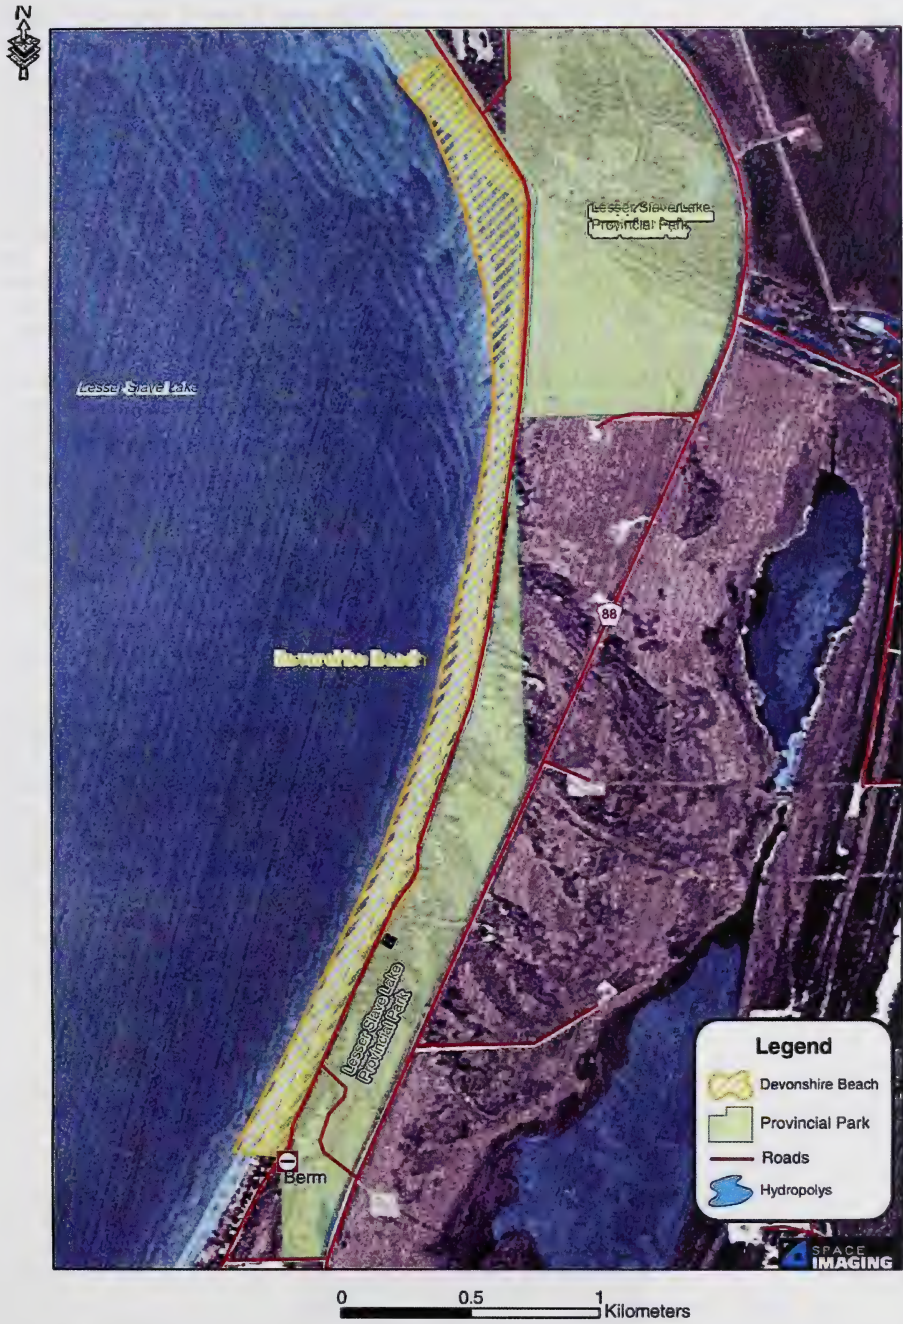
Figure 1. Beach ridge significance and disturbance study area along Devonshire Beach.

Lesser Slave Lake, located approximately 250 km north of Edmonton, is the second largest lake in Alberta, second only to the Lake Claire - Lake Athabasca complex that is located in the northeast corner of the Province (Bentz and Saxena 1993, Brandford and Hanson 1990). The lake has a surface area of 1,150 sq km and maximum depths of 21 m (Bradley 1980). The large size of the lake allows strong westerly winds to sweep over it, which causes a set-up at the east end of the lake and a decline in water levels at the west end. This oscillation can result in waves several feet high at the southeast end of the lake. Fine sand beaches at the east end of the lake are maintained by a combination of high water levels and high energy storms, drawing large amounts of sand from the headlands and depositing it in long shore drifts on the beaches. Most of the thicker sand deposits are found along Devonshire Beach, which is located in Lesser Slave Lake Provincial Park, as shown in Figure 1.

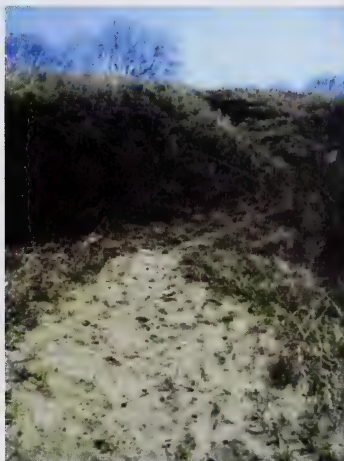
Devonshire Beach, with its clean white sand attracts many tourists, and is a popular recreation site for local people. Devonshire beach represents one of the best recreational beaches in the province (Bradley 1980) and hosts an annual sandcastle competition. A former stretch of Highway 88 located on top of the beach ridge is now used as access to the beach for recreational use. A number of pull off areas are located along the ridge and a large paved parking lot is located on the backside of the current beach ridge. The area has undergone some reclamation in the 1970's to control the movement of sand caused by human disturbance to the area (Lesko 1974). The reclamation was deemed successful and today much of the beach ridge is vegetated and stabilized, with the exception of a few blowouts along portions of the beach ridge as shown in Figure 2.

Figure 2. Devonshire Beach ridge.

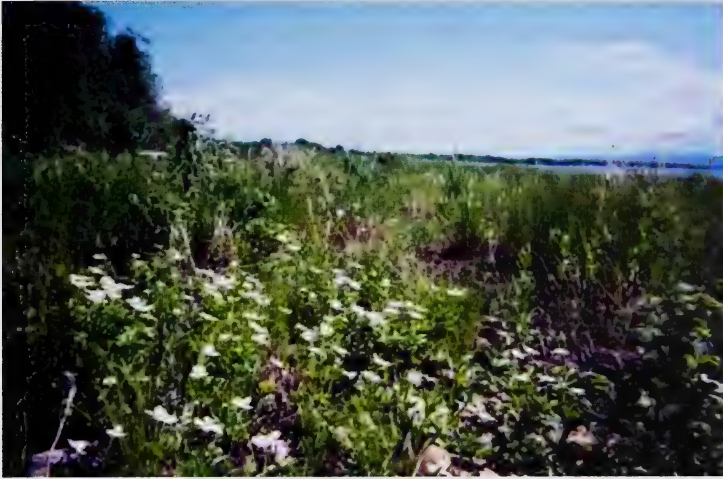
During the vegetation survey in June 2004 a large number of flowers were in bloom in the ungrouted sections of the beach. These flowers provided habitat for a variety of butterflies (Figure 4).

Figure 4. Photo of ungrooved beach providing butterfly habitat.

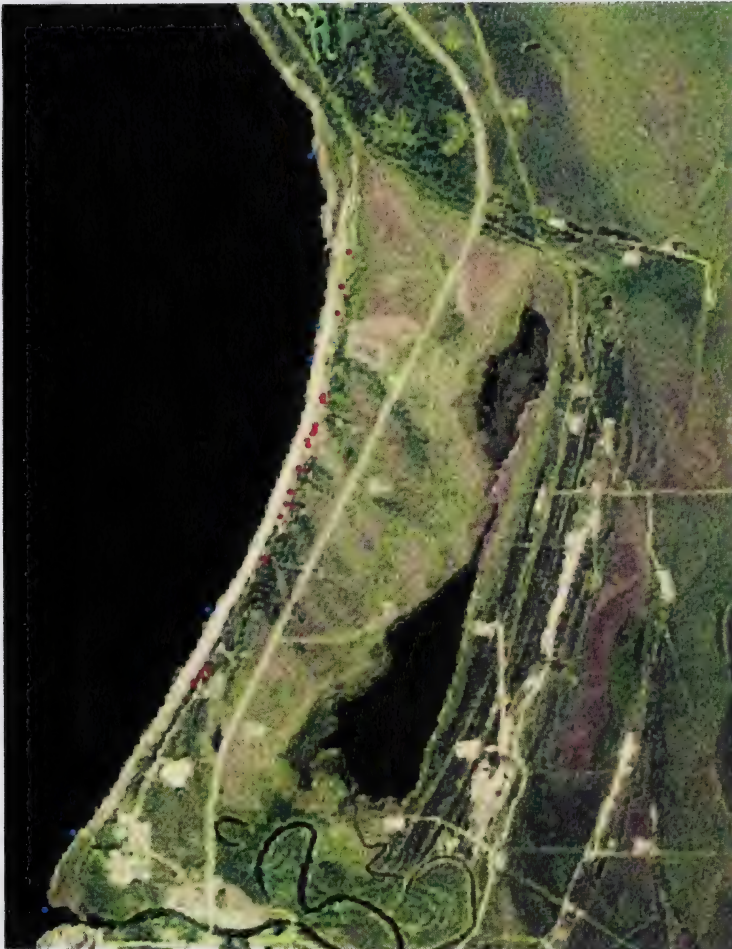
Figure 5. GPS locations of disturbance along Devonshire Beach are red dots on the map.

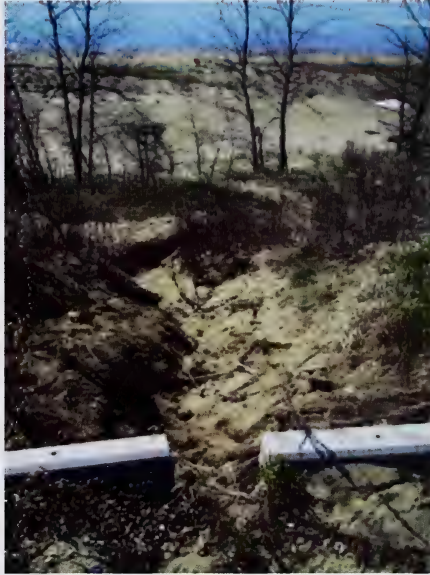
The second series of disturbances to the beach ridge are the small pull-offs that occur on the beach side of the road. These pull-offs show signs of erosion resulting primarily from trails used to link the parking lot on the top of the ridge, to the beach. Some of the pull-offs have signs discouraging the damage of vegetation caused by trampling, however informal trails do exist and erosion is evident (Figure 8 and 9). Some pull-offs also had some gravel mixed into the top layer of the sand. It was assumed the gravel was introduced during road construction and maintenance activities.

Figure 6. An example of erosion downslope from the pull-offs on the ridgeline.

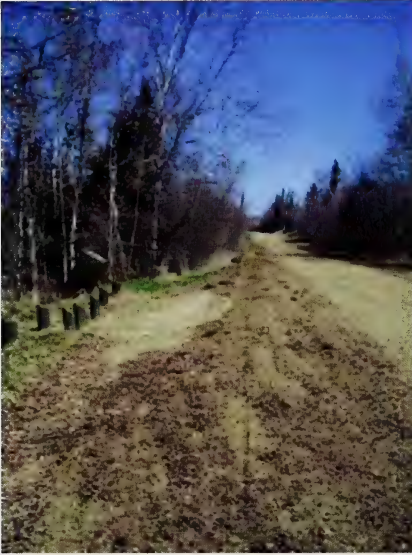
Figure 7. Road located along Devonshire Beach ridgeline.

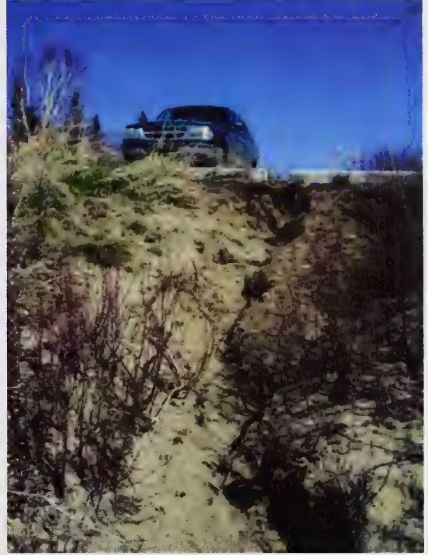
Figure 9. Erosion associated with trails from pull-offs.

Erosion of the ridge is readily apparent from trails that connect pull-offs situated along the main gravel road down to the beach. Along these uncontrolled trails vegetation is lost or destabilized and sand migration occurs often creating rills and gullies. Some measures are in place such as fencing and signage to limit the damage to the beach ridge, however erosion is still evident along the beach ridge that would likely not occur under undisturbed conditions. This erosion is the major disturbance that should be assessed for any future management plan.

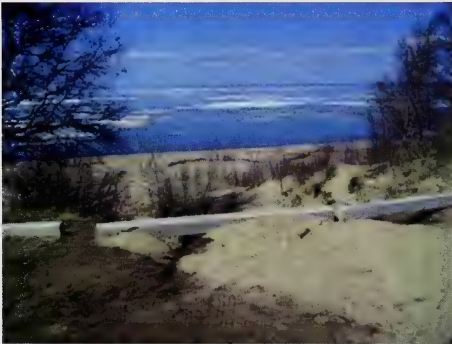
Figure 8. Erosion associated with trails from pull-offs.

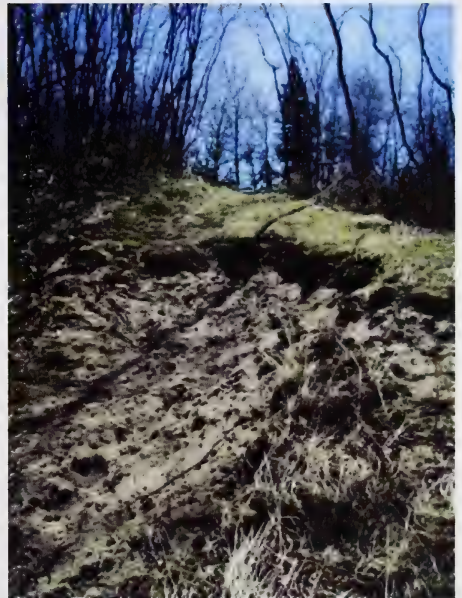
Natural disturbances also occur on the beach ridge. Areas of erosion were noted as slumps and rills where man-made influences were not readily apparent (Figure 10 and 11). These areas were often associated with steeper portions of the beach ridge, but the disturbances were isolated and limited in extent.

Figure 10. Natural disturbance - small slump.

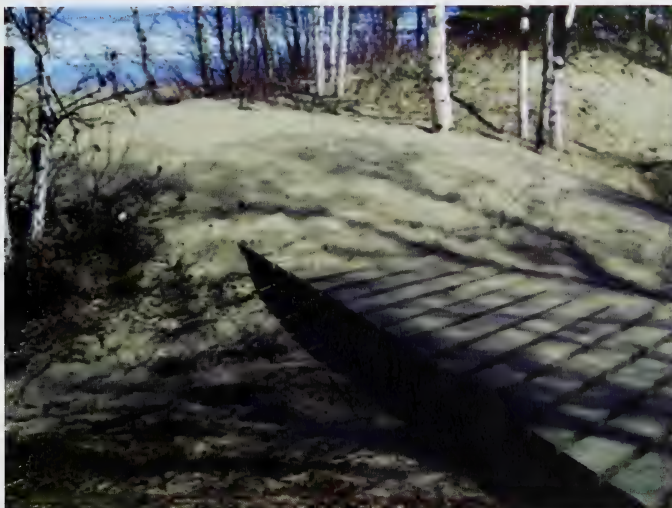
Figure 13. Boardwalk with drifting sand.

Moderate Mediation. Historically, a number of steps have been taken to control the drifting sand along the beach ridge. These mitigative measures include fences, boardwalks, stairs and revegetation. Using this option the erosion control measures would be further encouraged and developed along the entire length of the beach. For example, boardwalks have been constructed along a portion of the south end of the park. These boardwalks are useful, however each year they often become covered by drifting sand (Figure 13). Jol (2004) recommended duplicating measures undertaken in similar coastal situations in Washington. There, boardwalks are suspended to let natural vegetation grow underneath, while still allowing for access to the beach. He also recommended that more boardwalks could be built along the beach.
